**Hang Gliding and Paragliding Association of Canada /
Association Canadienne de Vol Libre**

FLIGHT SAFETY INVESTIGATION REPORT 2023-002

APRIL 27, 2023

LUSKVILLE, QC, CANADA

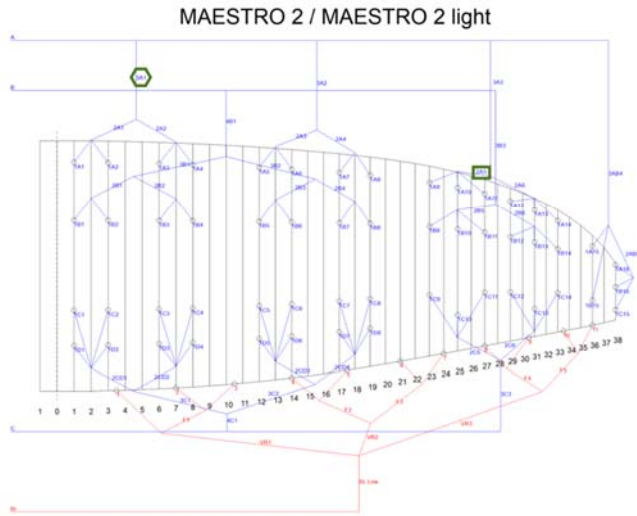
Figure 2: Damage to left side

Several lines on both sides of the wing were damaged (see, Figure 1: Damage to right side & Figure 2: Damage to left side). Likely, the damaged lines on the left side were torn after the accident or cut during rescue operations. On the right side of the wing, two lines in the upper line cascades show signs of repair that were done before the flight. Those two lines are 2B5 Right and 3C3 Right. Line 2B5 was repaired and covered with a heat shrink tube (see, Figure 4: Line 2B5 right). When the line was inspected at the workshop, the knot had either come undone or the line had ripped. Line 3C3 appeared to have been repaired with an extra piece of line and an intricate knot (see, Figure 3: Line 3C3 right). The line was torn just above the knot when the wing arrived at the workshop for inspection. Anecdotally, LP1 recalls that the pilot had radioed him prior to his flight and indicated that he had needed to repair one of his lines with a knot.

torn line with signs of repair
-

out line
-

torn line with loose knot

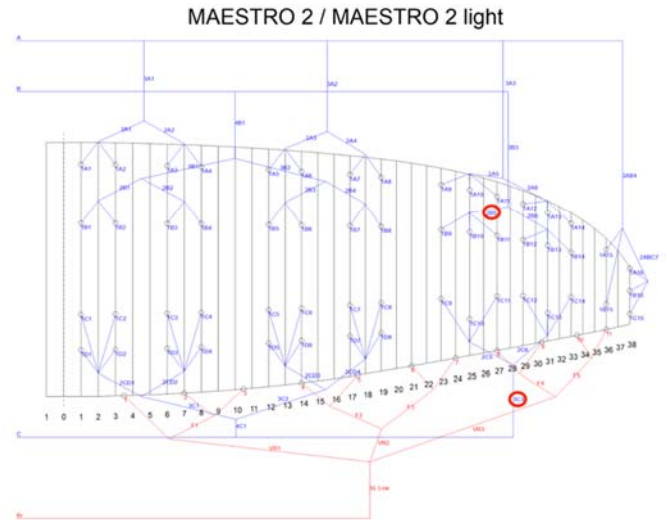
Figure 1: Damage to right side

It is also possible that the two lines in the upper cascade on the right side that showed signs of repair ripped during the flight. The experts consulted for the report agree that this would cause a critically dangerous situation, without necessarily making the glider uncontrollable. Pressure on the A lines on the right side would increase, causing a turn to the left, possibly followed by a collapse on the right side.

torn line with signs of repair

2. **If you have any doubt about your glider, do not take off** – Pilots often underestimate the risks or overestimate the quality of their repairs. Make sure that you have access to a trusted paragliding repair shop and do not attempt to repair lines yourself. Any knot is likely to decrease the length of the line below its tolerance (typically 1cm) and reduce its resistance.

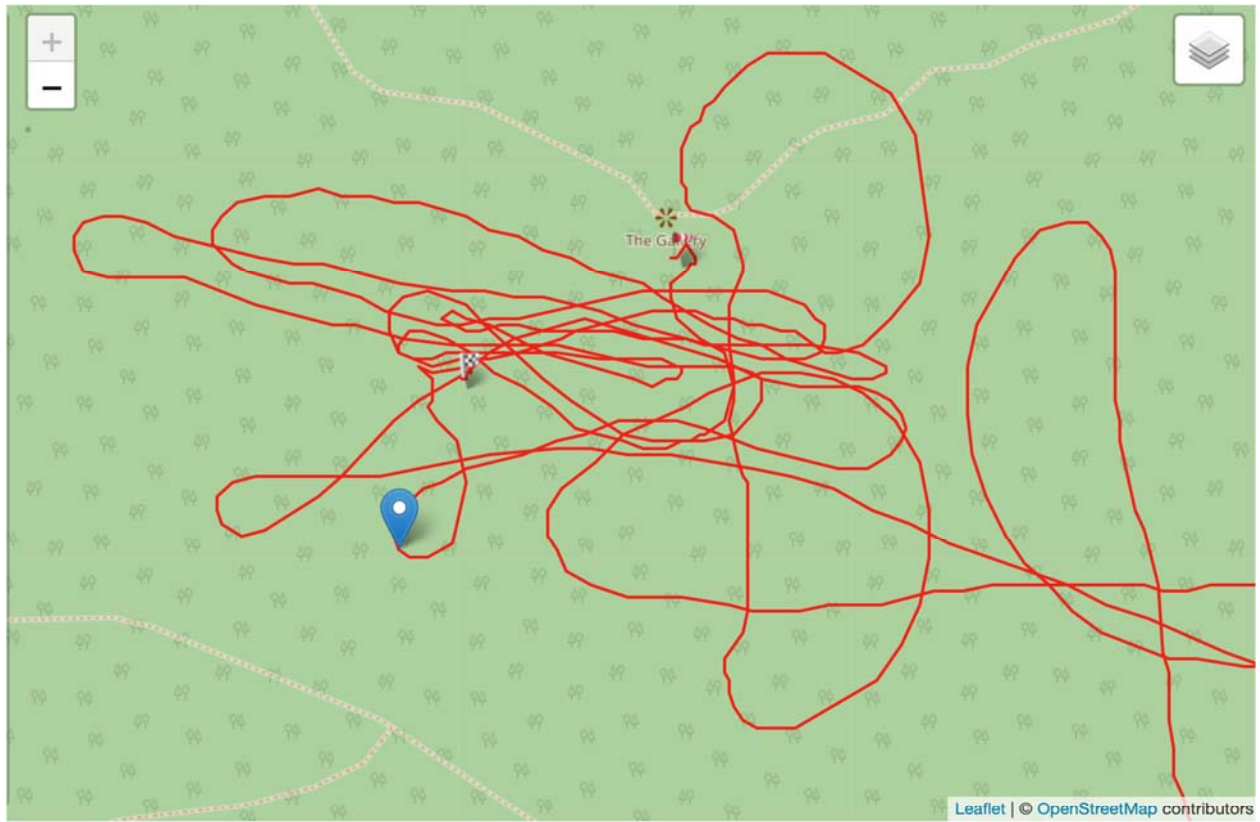
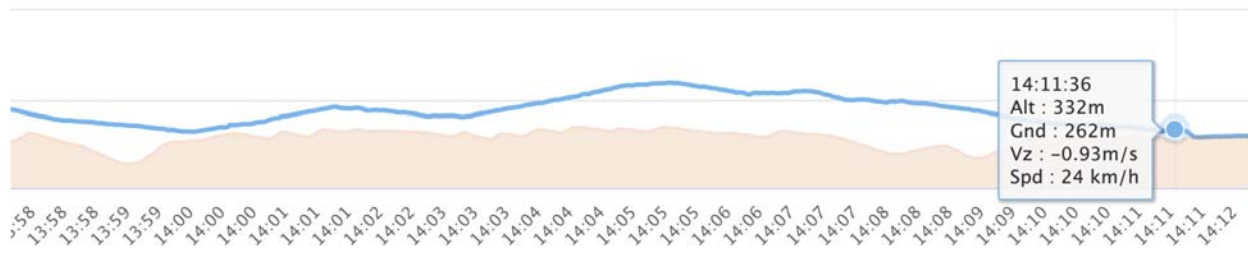
Figure 5: Flight path before the accident

At approximately 2:07 p.m., the pilot left the second thermal and flew Eastwards, then Westwards back to the take-off area. After two figure eight turns, the pilot entered what appears to be a third figure eight turn at 2:11:30 p.m., at an altitude of 333 meters or about 70 meters above ground. Instead of flying away from the ridge after a 180-degree turn, the track log indicates that, at 2:11:38 p.m., the pilot continued his turn for another 90 degrees. The track log subsequently shows an almost straight flight path North towards the ridge for another 10 to 14 seconds, covering a horizontal distance of 53 meters, with a loss of altitude at an average rate of -3.2 m/s over 14 seconds (see, *Figure 5: Flight path before the accident*). Between 2:11:42 p.m. and 2:11:48 p.m., the altitude decreased from 329 meters to 296 meters while flying towards higher ground, suggesting a descent rate of -5.8 m/s averaged over 6 seconds.

An abrupt loss of altitude is consistent with the track log, which shows a rapidly increasing altitude loss over the last 14 seconds of the flight. In high rotation scenarios such as an autorotation, the GPS typically no longer records a spiral but will show a nearly vertical descent with some latitudinal and longitudinal noise. In this case however, after the sink rate started to increase and over the last 14 seconds of the flight, the track log shows that the pilot covered more than 50 meters in horizontal distance.

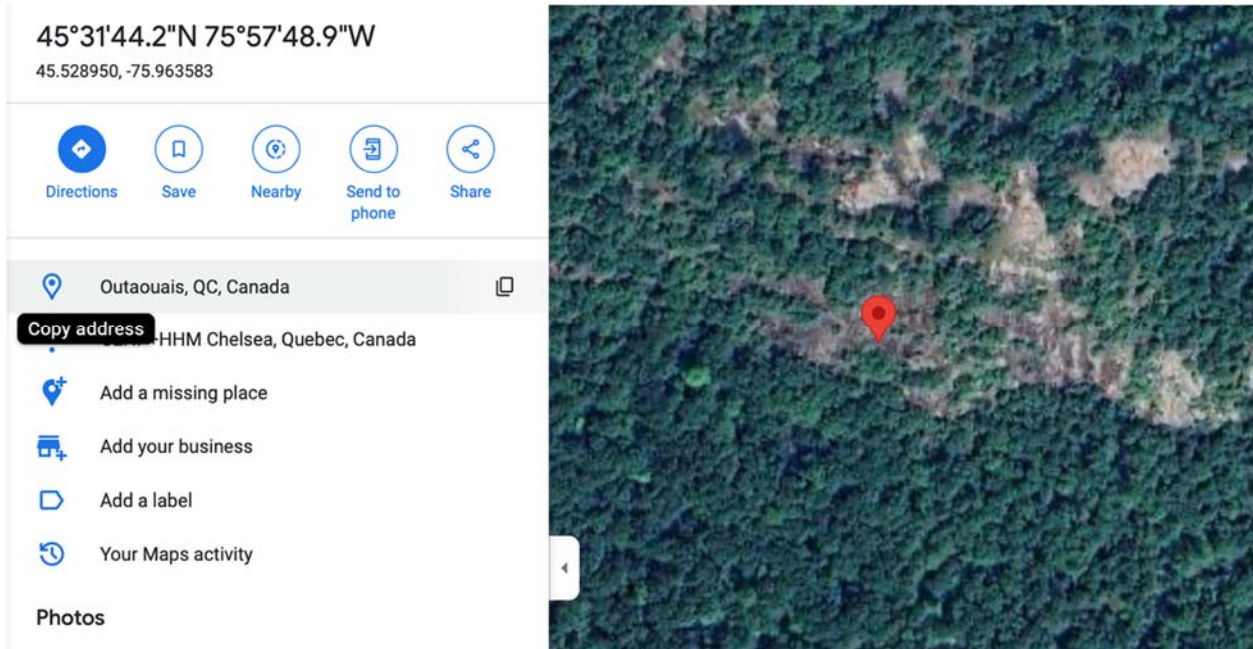
Figure 6: Site of the accident

The site of impact is a steep, small rock face surrounded by trees (see, *Figure 6: Site of the accident*). Witness LP2 reports being the first one on scene and immediately realizing the seriousness of the accident. He recalls the victim behind unconscious, with laborious breathing and an open fracture on the right arm. Witness LP2 remembers calling 911 and waiting about 60 to 70 minutes before the arrival of first responders. Witness LP2 and witness LP1 recall that the rescue operation was complicated and lasted more than 4 hours. The injured pilot was airlifted to the hospital. As a result of the accident, the pilot suffered multiple life-threatening injuries and unfortunately passed away a few days later.
